FIAT SERVICE LETTER

SUBJECT: REAR QUARTER WINDOW

VEHICLES: 128 - 2 DOOR CUSTOM 1976 MODEL

SERIAL NO. APPROX. 2.009.000

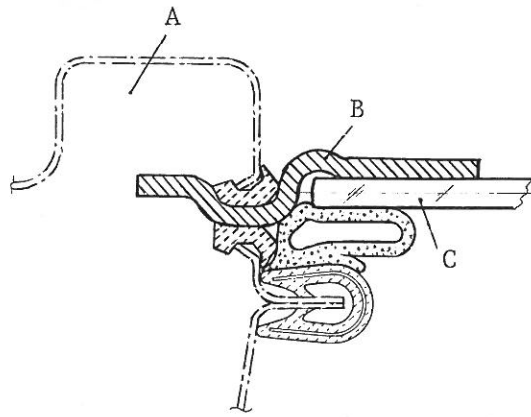
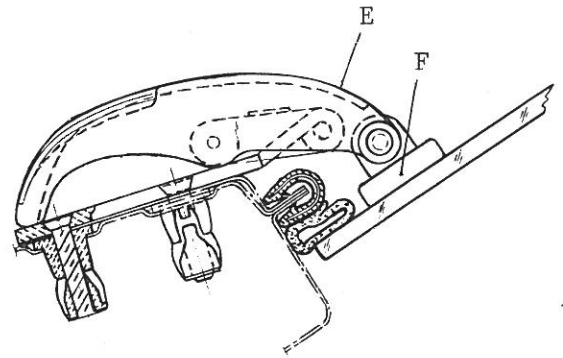
1)

CONDITION: Possible separation of the latch and hinges from the rear quarter window

CAUSE: Improper bond of the latch mounting pin and hinges to the glass.
