SL 551-49  
10-22-81

# FIAT SERVICE LETTER

**SUBJECT:** TROUBLESHOOTING STARTING SYSTEM

**VEHICLES:** 1980-81 BRAVAS EQUIPPED WITH AUTOMATIC TRANSMISSION

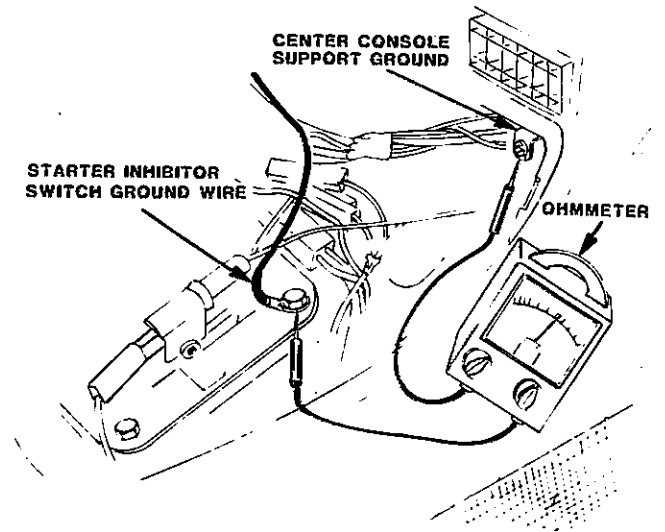
- Disconnect battery ground cable.
- From inside the passenger compartment, remove the shift lever quadrant.
- The inhibitor switch ground wire is secured to the upper passenger side corner of the shift quadrant support.
- Using an ohmmeter, make sure inhibitor switch wire is properly grounded, even when shaking the connector.

NOTE: Use the center console support as a ground for ohmmeter.

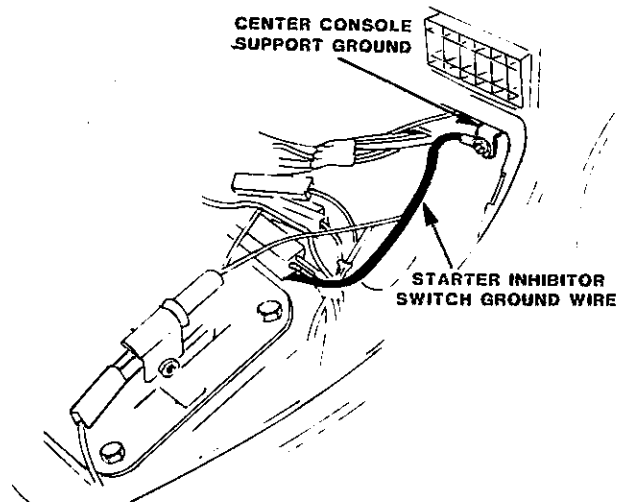
- If a proper ground is not evident, relocate inhibitor switch ground wire from the shift quadrant support to the center console support.
